# Asset management Refurbish, replace

*During early 2003 the Umgeni Water Operations Division experienced difficulties in coordinating water balancing checks in the Ntabaskop and Insiminya areas due to severe water leakages in most of the ferrocement reservoirs within the reticulated network. In a combined attempt to investigate and resolve the situation, the Umgeni Water Design Support Division was tasked to prepare a comprehensive report together with recommendations of repair, refurbishment or replacement. This month, **Water&Sanitation Africa** takes a look at this investigation and its results.*

# Or repair?

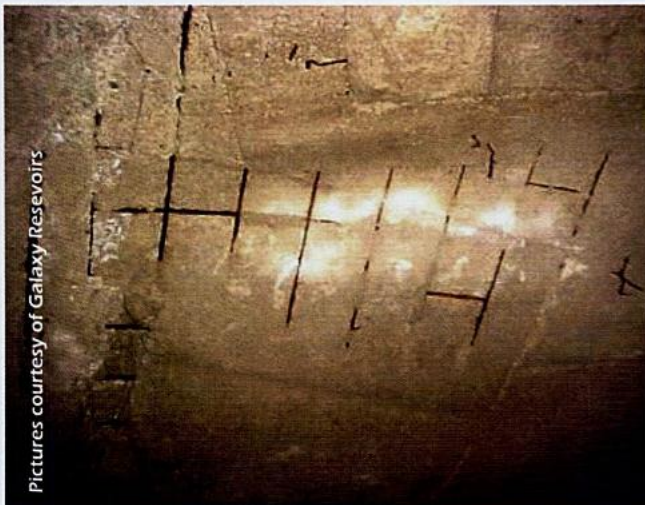
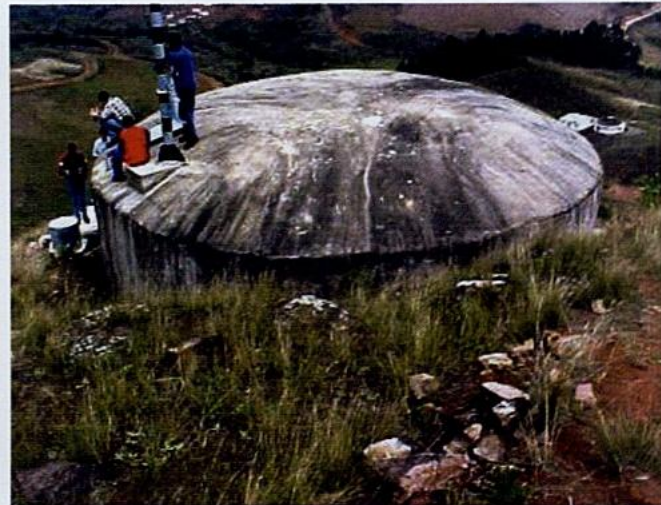
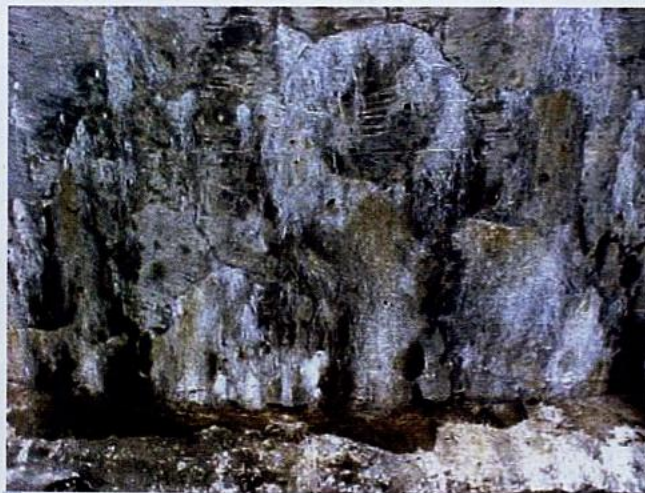
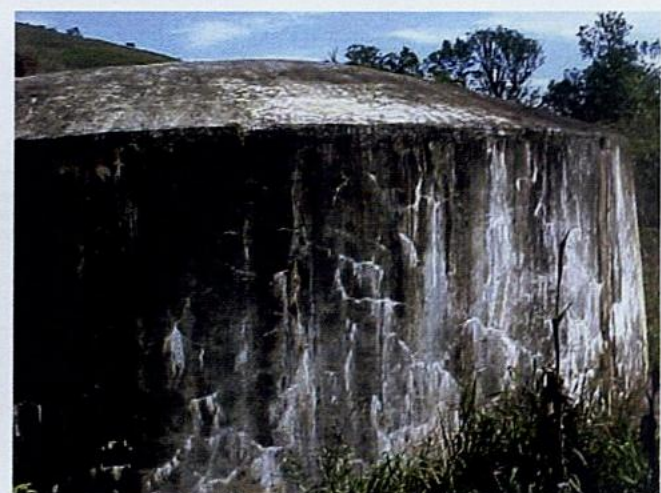
Original ferrocement reservoirs showing extensive leaks, cracks and sprawling of reinforcing internally

200kl structures. The basic construction method of all the ferrocement reservoirs was the same – they were circular with dome-shaped roof designs; wall heights of 2.1m and 80mm, thick reinforced with 3.6mm x 100mm mesh placed two layers back to back. The reservoir floors were of 5.6mm x 200mm square mesh covered to form a 100mm thick concrete floor slab.

Close investigations of the reservoirs revealed that their failure was largely attributed to substandard and shoddy workmanship, characteristic of many labour-intensive RDP projects of the time. The larger cracks over the entire structure could have been due to weak concrete mixes. The very difficult terrain, hills and poor site access, compounded by very limited access to good clean water and raw materials are

In a record period of less than three months the failing ferrocement reservoirs, totalling 17 units were demolished, the existing floors levelled where necessary and new Zinalume Galaxy panel reservoirs with Aqualiner were installed and commissioned.

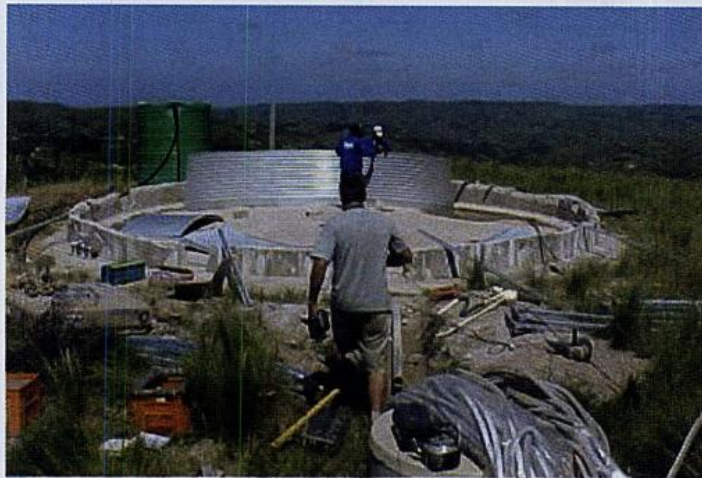
Installation of Galaxy Reservoir inside the 'old reservoir' footprint  
– panels had to be carried up the hill to final location

After it was decided that these options were not feasible, the team looked elsewhere and came across Galaxy Reservoirs. These reservoirs, supplied, installed and commissioned by SBS Water Systems of Pinetown, KZN, offered an affordable, safe and efficient water storage solution to the Ntabaskop and Insiminya Community Water Supply Scheme's increasing water loss problems.

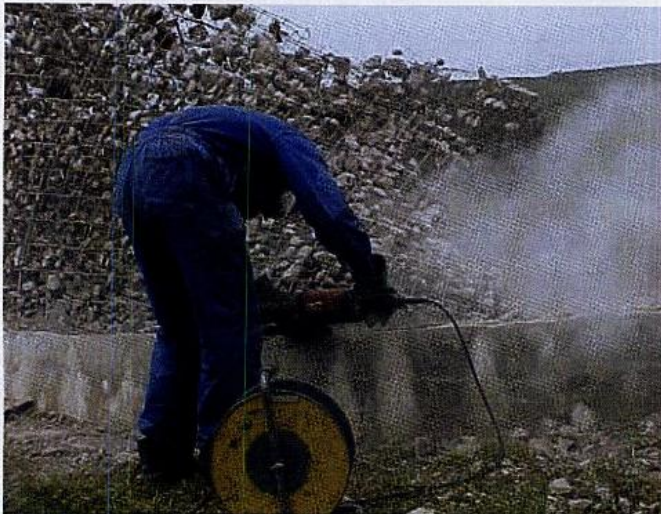
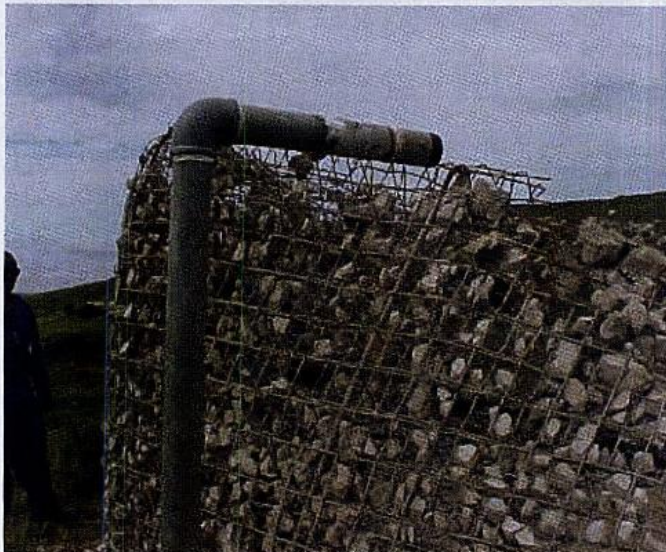
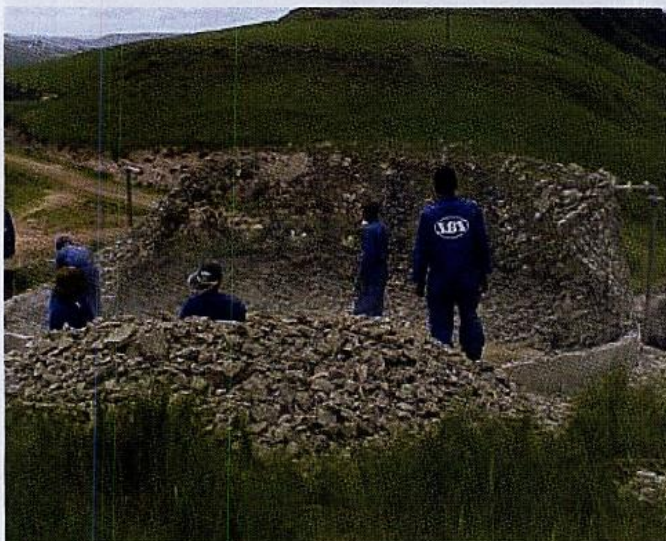
Above pictures show demolishing of reinforced ferrocement reservoirs, walls demolished to floor level, leaving concrete base only
