Pipe jacking the N3

The N3 pipe jacking project was undertaken in advance of the construction of a R92 million bulk pipeline project, commissioned by Umgeni Water, to boost the water supply from Pietermaritzburg to Durban by 1 024 l/s.

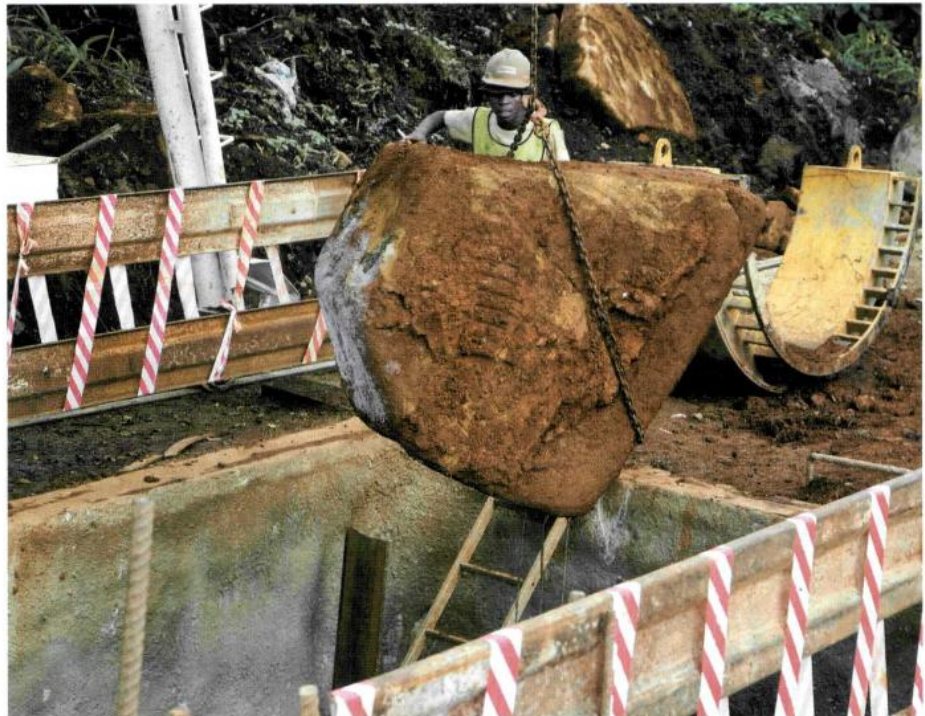
ABOVE Boulders removed from inside jacking sleeve

Immediately following this, the shield entered rubble fill that had been used to raise the level of the N3. Boulders of up to 1.3 m had to be dragged out or blasted into smaller pieces. Inevitably, a void started to form above the sleeve as boulders fell in to replace those removed. The excavation was under the north-bound fast lane and as haulage trucks tend to use this lane at night, the additional load and vibration caused further rock movement. It was decided to seal the void with sandbags and to grout behind these. Unfortunately, one rogue boulder was dislodged above the sleeve and demolished the sandbag wall.

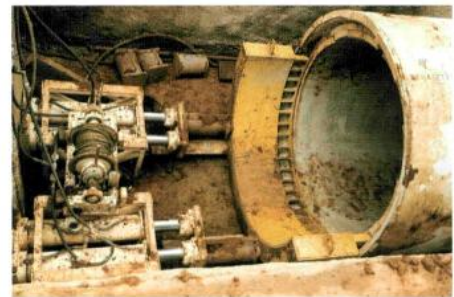
RIGHT View of jacking pit showing jacks, jacking ring and concrete sleeve

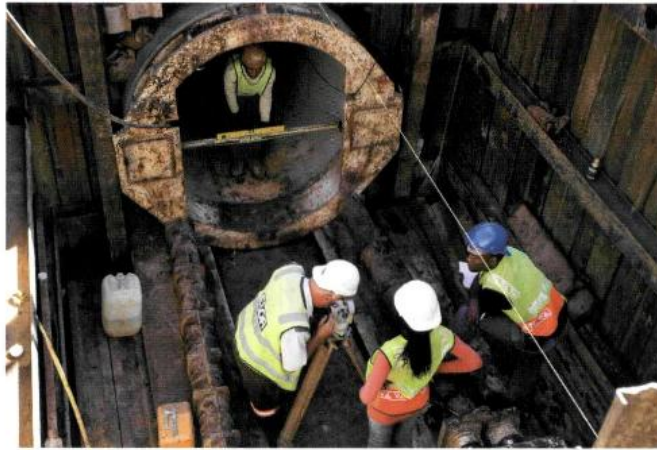
ABOVE Line and level control of pipe-jacking operation
